Acid Solutions®

Contaminated Water Treatment Services

65 megalitres of low pH Metal contaminated water treated for irrigation disposal.

November 2008

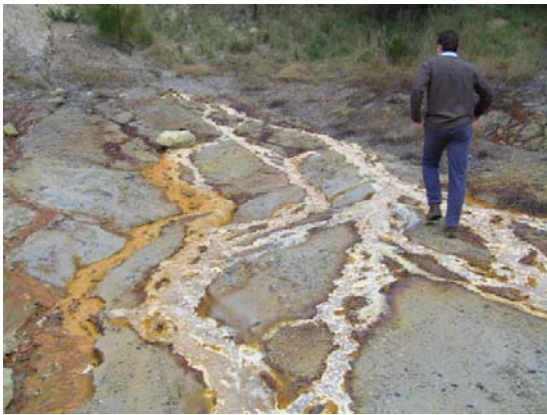
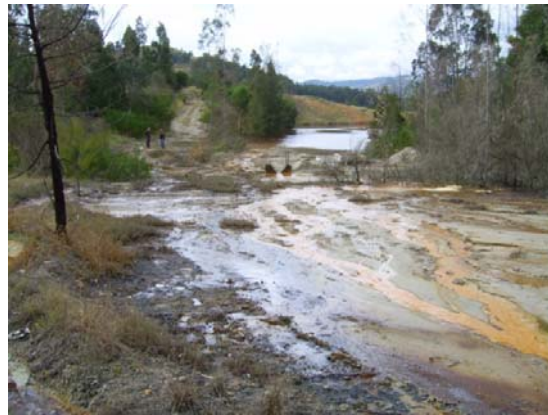
The samples taken and tested from the leachate seeping from beside the Adit showed a ph of 3.26 with a conductivity of 6.38ms/cm. The total Actual Acidity (TAA) measured 1530 Mg/l and Total Potential Acidity (TPA) of 1580 Mg/L with extremely high levels of Ferrous Iron apparent.

Contaminated Water leaching from side of Adit seal

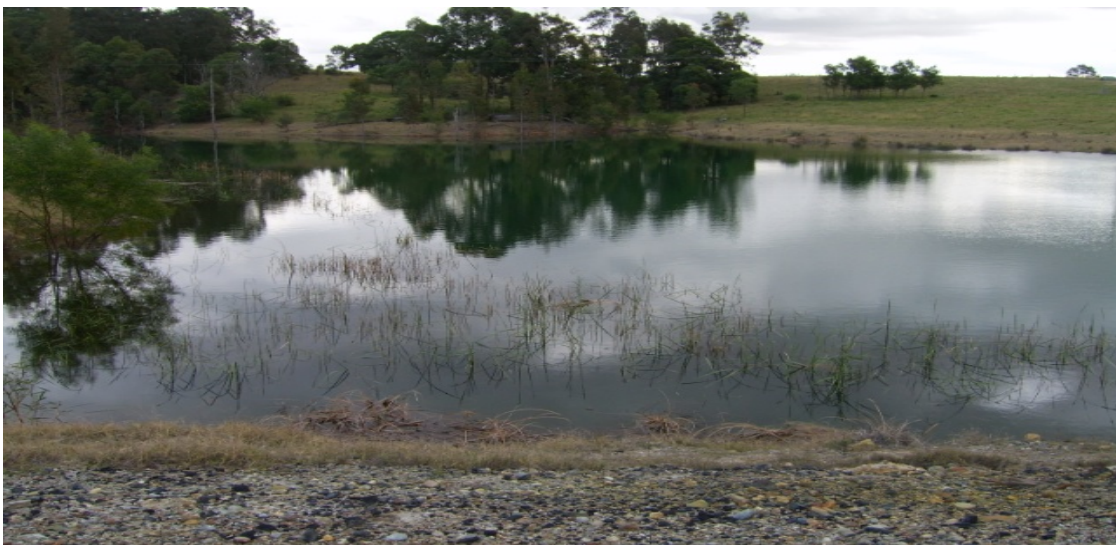
Holding Dam - 65 Megalitres

Samples taken from the holding dam had a ph of between 2.95 and 3.44 with a conductivity of 3.59 to 4.16ms/cm. The Total Potential Acidity (TPA) measured between 295 to 465Mg/L with high ferrous Iron levels.

The holding dam showed stratification with high ferrous iron and a mild smell of hydrogen sulphide in the deeper water when raised to the surface.

The Dam was treated insitu using *Acid Solutions* Patented Treatment system called the C.R.A.B. and 3 different specialized applicators.

After the surface and mid depth ranges were initialized with reagent we then applied reagent to the lower depths using our "stratification buster". This applicator applies reagent accurately to the lower depths and ensures the reagent penetrates the stratification and helps to oxidize the ferrous iron to speed treatment and prevent future re-acidification.

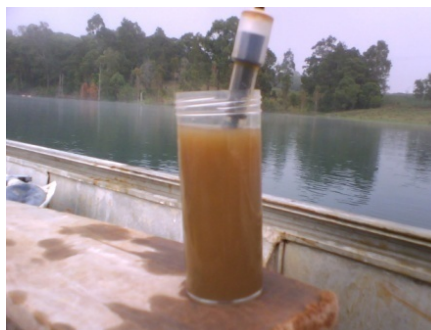
Floc was also sampled from the bottom when testing water quality. This floc showed the normal coloration of precipitated Ferric (oxidised) Hydroxide. The water/Floc did not drop in pH when Tested with hydrogen Peroxide which indicates (if endpoint pH is over 8.7) that the initial Ferrous Iron has been converted to Ferric Iron.

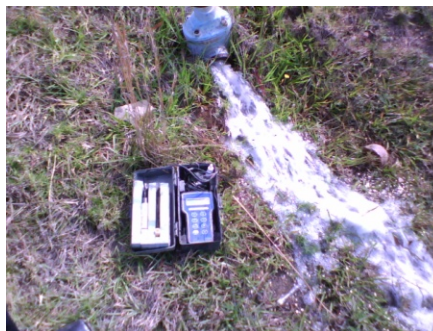
A dam drain point exists in the lower dam wall. It is understood that this extracts water from the lower level of the dam. Water was tested at this point and showed a pH of 8.82 and no Ferrous iron after flushing upon completion of the treatment process.

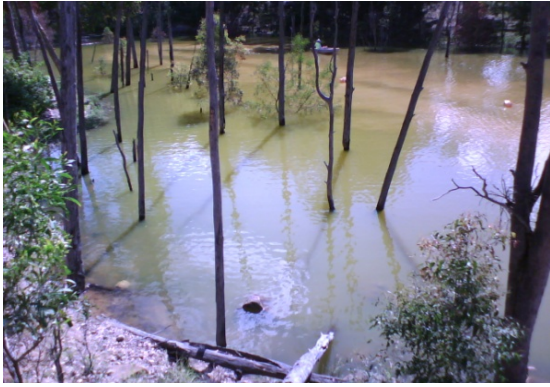
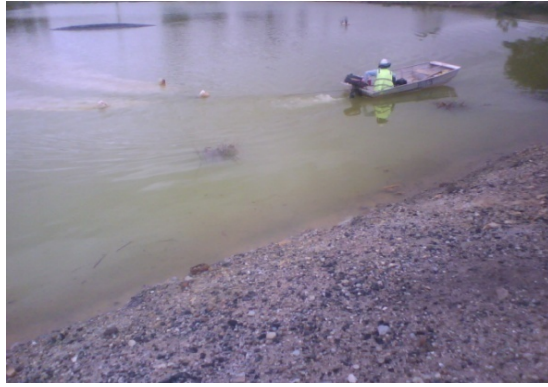
Initial Stages with high Ferric Hydroxide formation and precipitation.

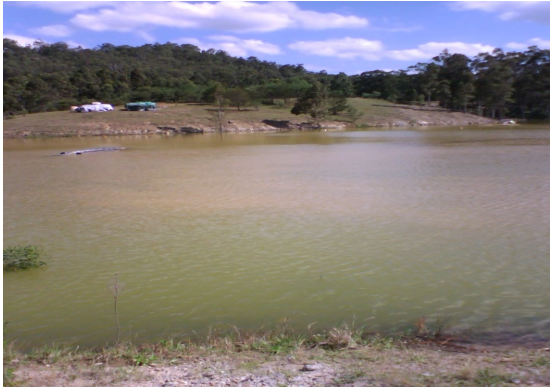
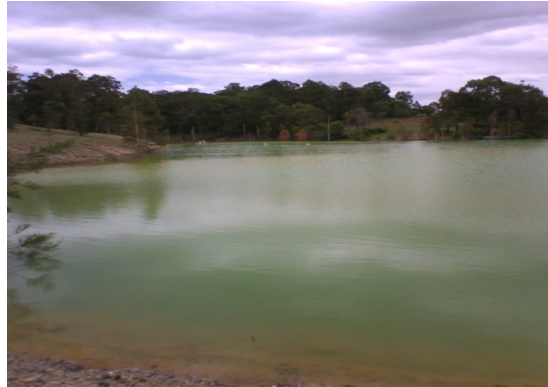
Mid stages with Aluminium precipitation starting.

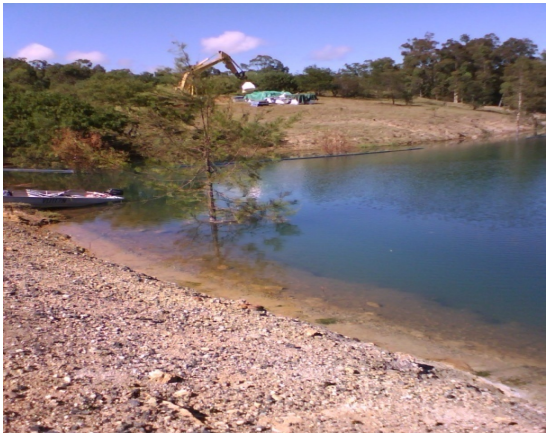
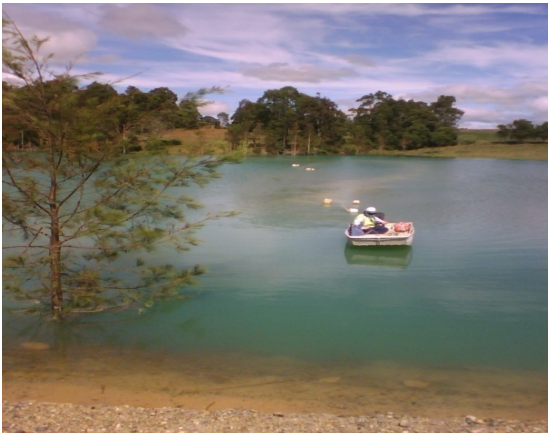
Final stages of treatment after neutralisation and metal precipitation is almost complete.
