200 megalitres of Copper Contaminated water treated for Environmental Protection. October 2009

Site Location Mt Isa, QLD

Site Problem Copper and Nickel Contamination

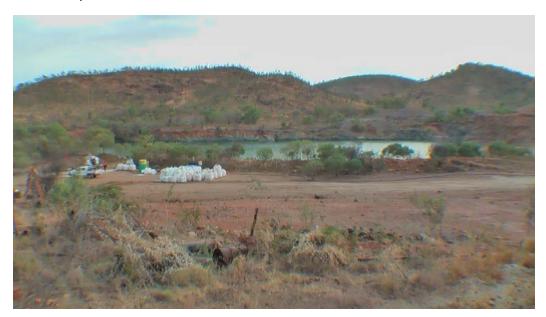
Approximately 200 Megalitres of contaminated water was contained in a decommissioned copper extraction pit approximately 140 metres wide by 220 metres long and up to 17.5 metres deep. The water had a pH of 7.8 and contained dissolved Copper and Nickel concentrations above release limits

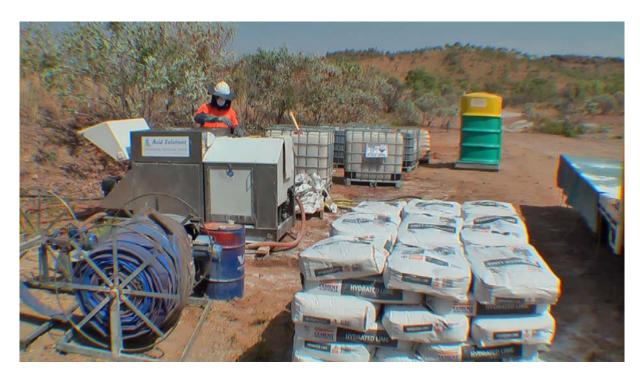
The Treatment Reagents used were Calcium Hydroxide (Ca(OH)2) and 2 other of our specialized reagents. These reagents when applied at the correct rates provide extremely efficient metal reduction when applied accurately and at the correct stage of treatment.

The method for treatment used was in-situ treatment. Reagents are applied in varying combinations and rates accurately throughout the water body with 3 specialized applicators to provide the required result.

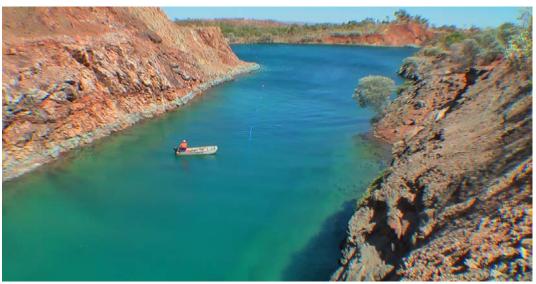
Water clarity after treatment.

Acid Solutions successfully completed the treatment of this site within 9 days. Our reagent combinations and application methods specifically targeted copper as the reagent for reduction to below the level required.
