FIXING THE ENVIRONMENT

Contaminated Water Treatment

Blue Green Algae Treated for Toxins and Suspended Solids to allow irrigation disposal. February 2009

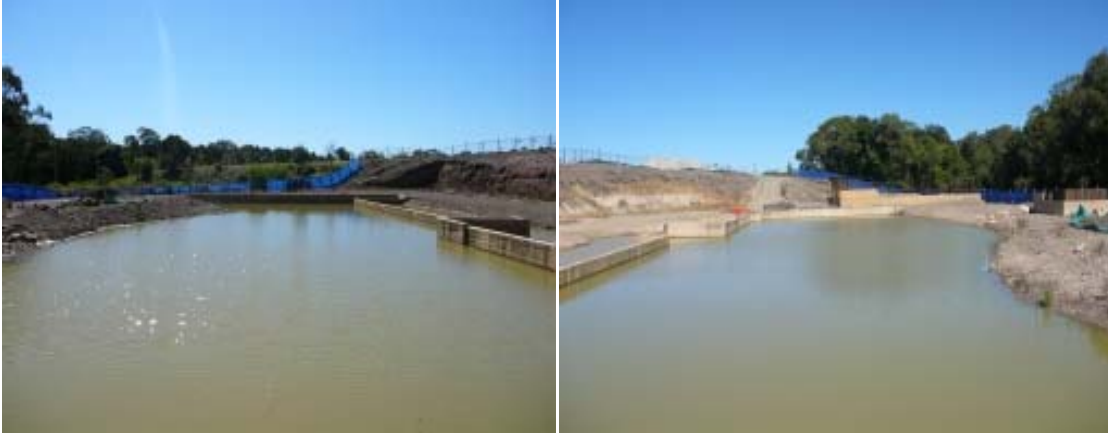
The site was catching nutrient rich water and sediment from a nearby construction site and golf course after heavy rainfall. The site developed a Cyano Bacteria outbreak over several months.

Treatment was required to improve quality and remove toxins and suspended solids to allow dewatering and irrigation disposal and eliminate the chance of wildlife poisoning from algal toxins.

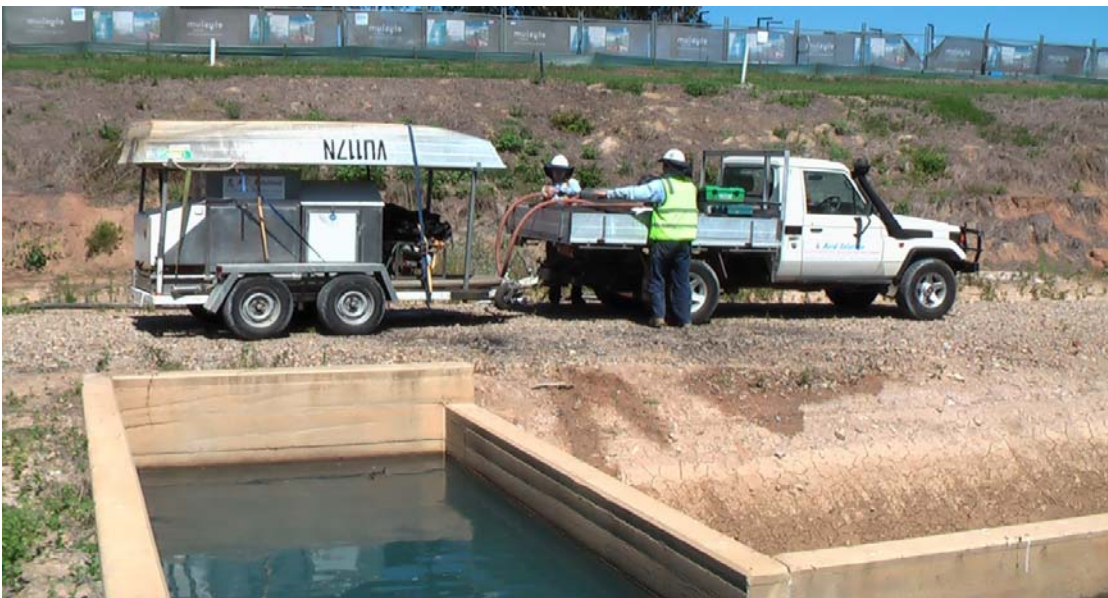
Approximately 2.4 Megalitres was contained in a pit 80 metres by 20 Metres and up to 1.5 metres deep. Water was to be treated to reduce suspended solids and remove algae and toxins to allow dewatering.

Acid Solutions used its patented water treatment technology called the CRAB™. The Calibrated Reagent Applying Blender. The Acid Solutions CRAB™ system provided a fast and highly efficient method to deal with this contamination.
