Acid Solutions®

Contaminated Water Treatment Services

685 Megalitre abandoned mine treated with 140 TONNES of reagent for Department of Mines and Energy to provide environmental protection before wet season rains.

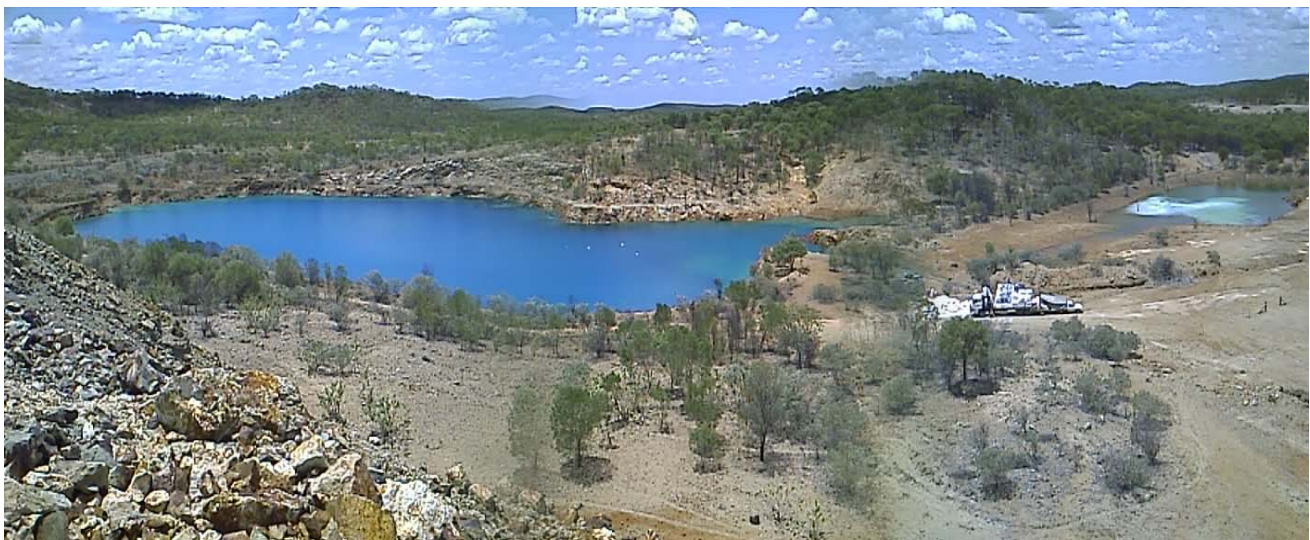
Contaminated Dams holding 687 megalitres

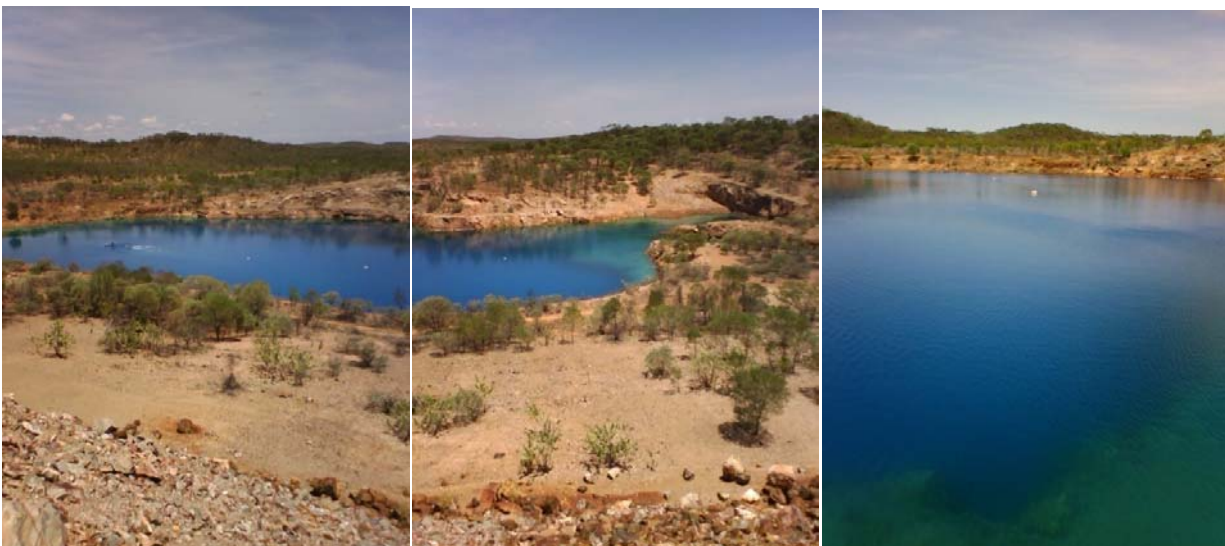
Site photos towards the end of treatment.

Note the water clarity

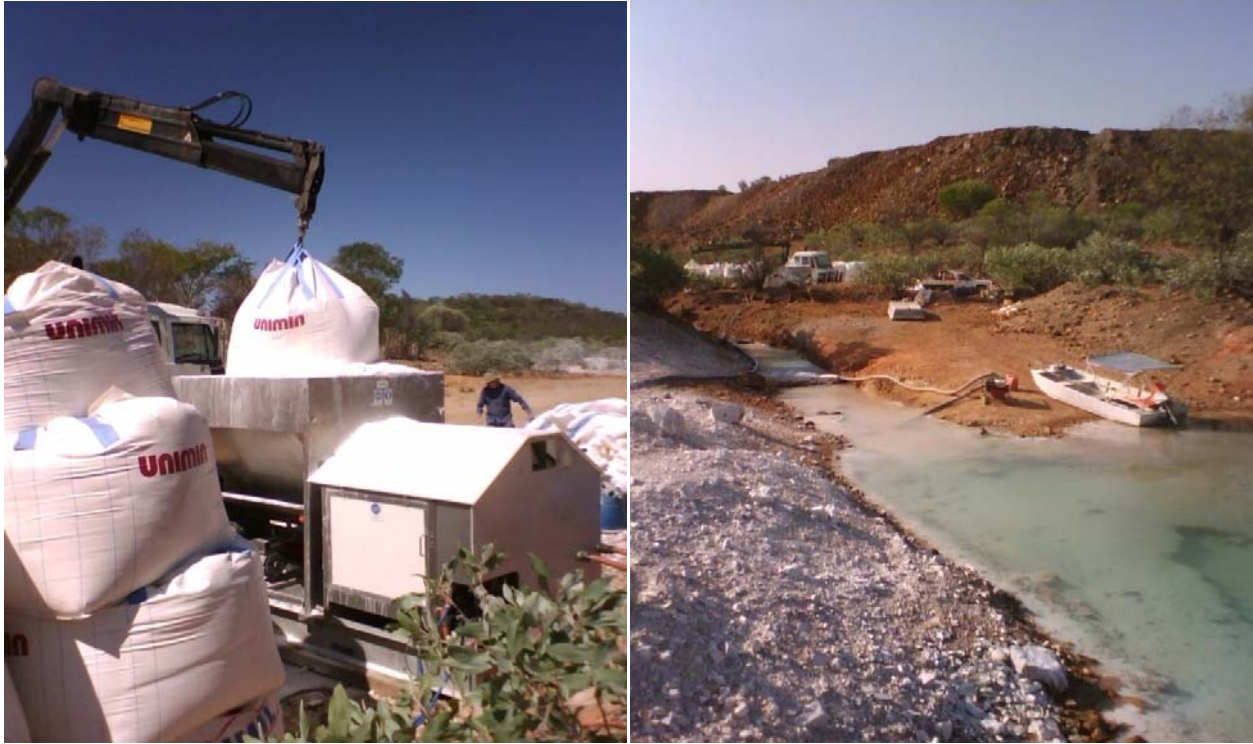
CATCHMENT DAM TREATMENT

The catchment dam was treated to a high pH to counter acidic runoff entering the site before overflow. The water contained in the dam was treated with excess reagent and the surrounding dry holding area was sprayed with concentrated slurry to help neutralize possible inflow of acidic water entering the site.

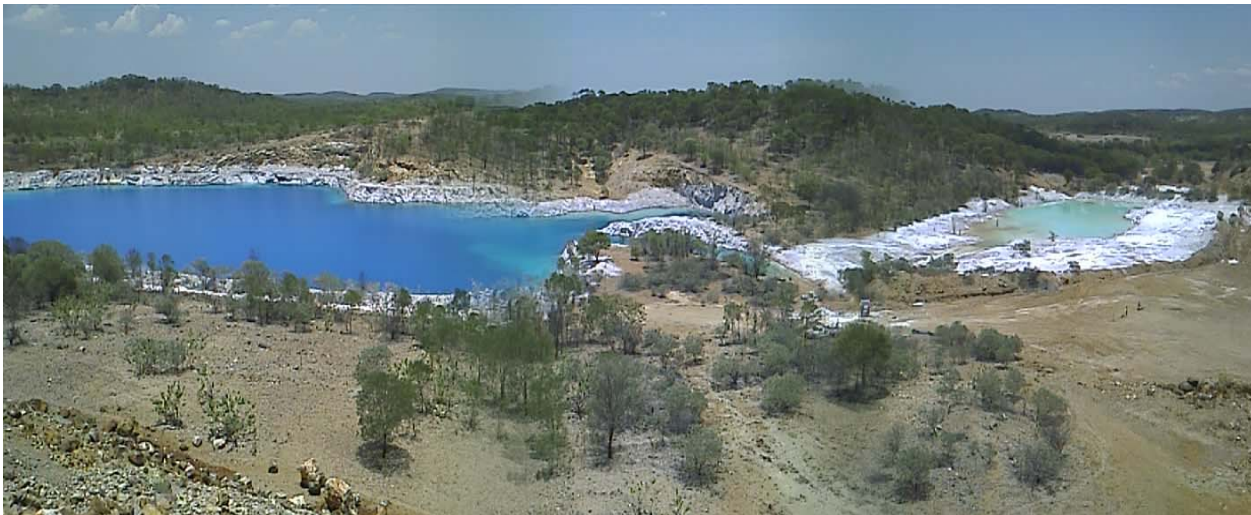
The rock faces surrounding the Main Pit were treated with 3500 Kilograms of reagent. This area equates to approximately 9000 square metres. Application rate equates to approximately 330 Grams per square metre.

Acid Solutions applied a concentrated reagent slurry of approximately 1 Kilogram to 5.5 litres of water to the pit surrounding areas. This was done to neutralize the acidity held crystallized on the rock surfaces and to help neutralize acidic water flowing over the treated rock.

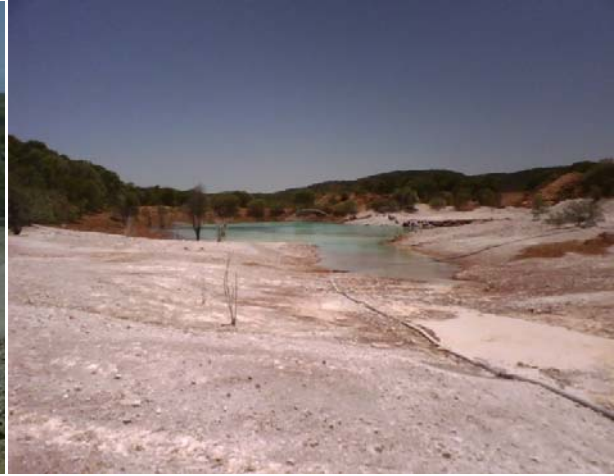
Catchment Dam after application.

The Catchment Dam, inflow drains, overflow and up to approximately 80 Meters downstream in the dry creek bed was also treated with a concentrated Reagent slurry. This area equates to over 15,000 square metres and was treated at a rate of 250 to 300 Grams per square metre.

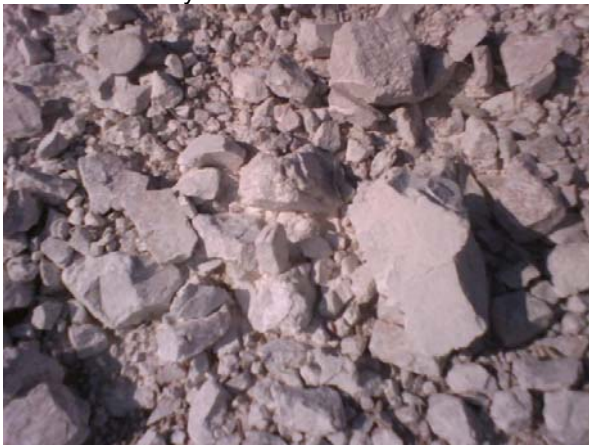
Close up of reagent coverage

This surface application was very successful with drying and bonding of reagents to the rock surfaces. A small treated rock was placed into a bottle with acidic Catchment dam water several hours after coating and shaken vigorously. The alkaline coating maintained its attachment to the rock surface and seemed to slowly reduce in thickness from acidic etching. This indicated rainfall would not remove the coating, only acidic water, which would then be reduced in acidity.

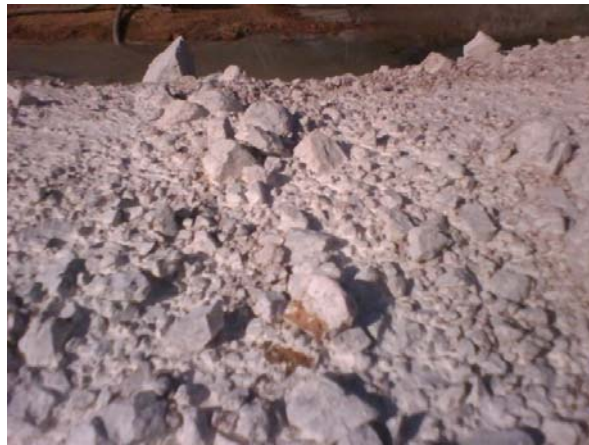
Rock removed to show efficiency of coverage

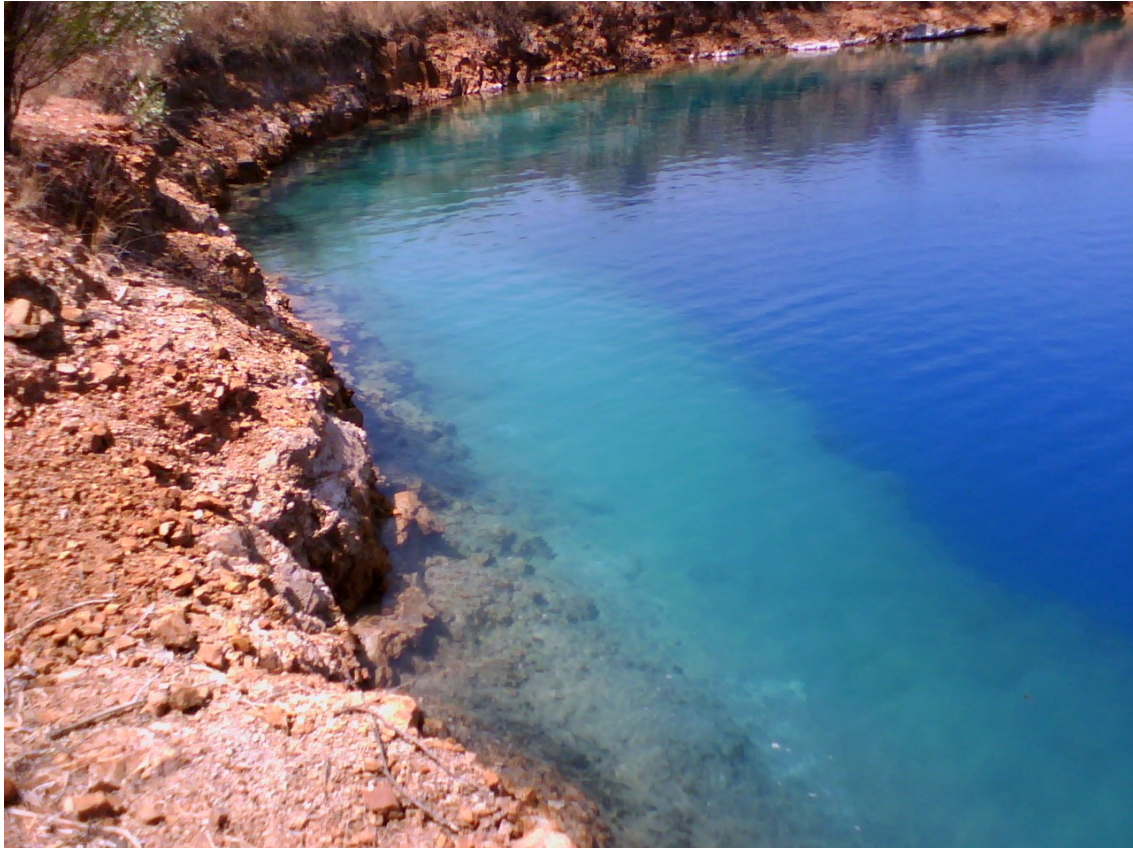
Water after treatment (7 Metre depth to visible bench)
