Contaminated Water Treatment

**EMERGENCY WATER TREATMENT
AT THE
MOUNT MORGAN MINE SITE
FOR
DEPARTMENT OF EMPLOYMENT, ECONOMIC DEVELOPMENT
AND INNOVATION.**

30 MAY 2012

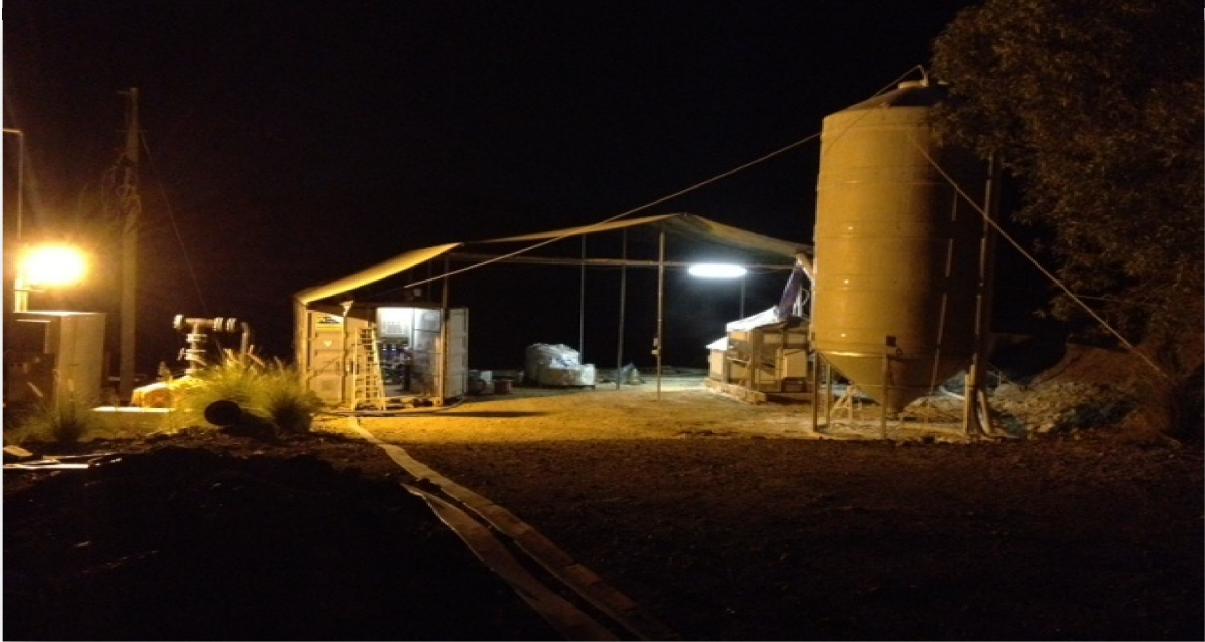
Containerised pumping and control systems with CRAB treatment system and 15 Tonne silo. The treatment system would receive reagents in both tanker loads and Bulk Bags.

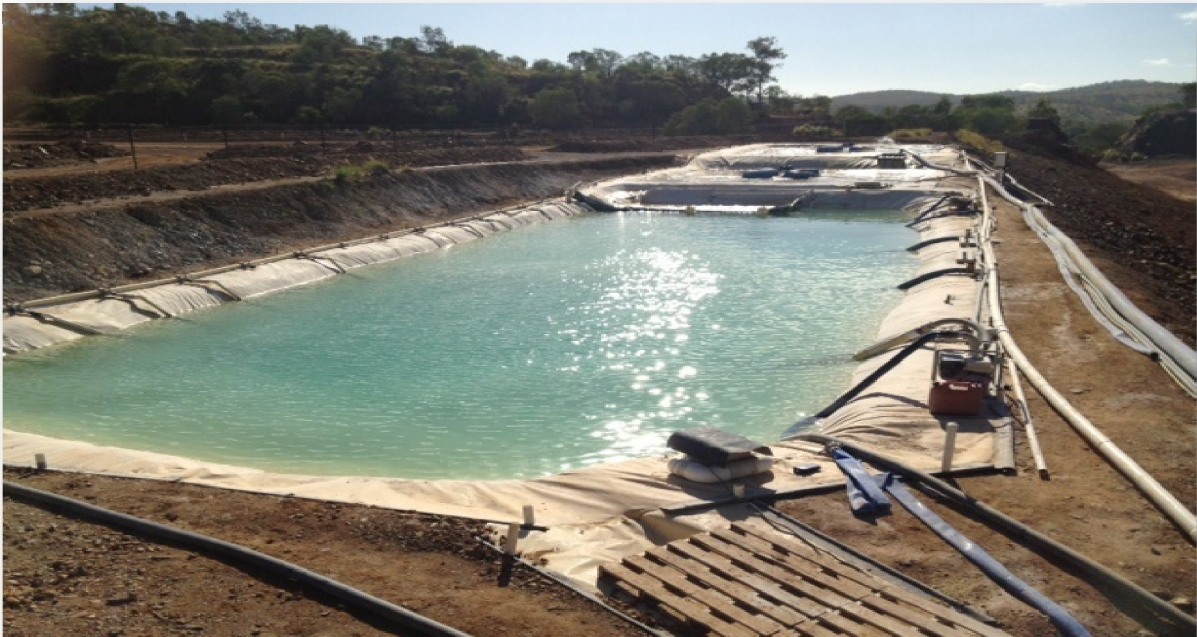
Short term, in-ground treatment and floc processing pits treating over 200,000 litres per hour.

Treatment was achieved at discharge rates ranging between 140,000 and 205,000 litres per hour. The average discharge rate was 168,800 litres per hour.

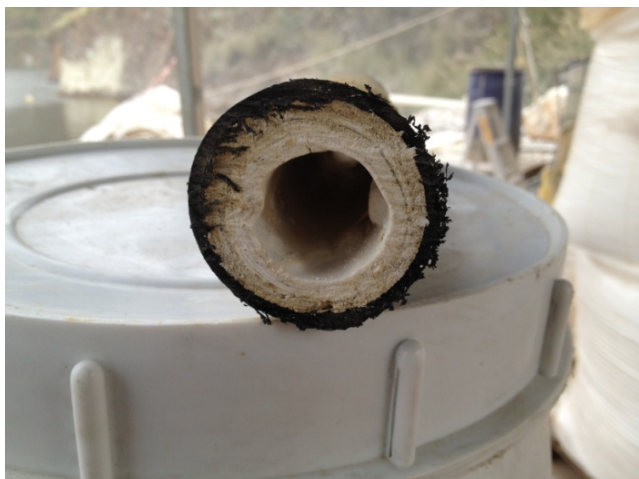
The extreme sulphate levels almost instantly formed gypsum on contact with reagents.

The photos below show blockages formed over several days.

Reagent pipeline blockage due to Gypsum formation.

This blocked pumps and pipe work until the process was modified to account for this problem.

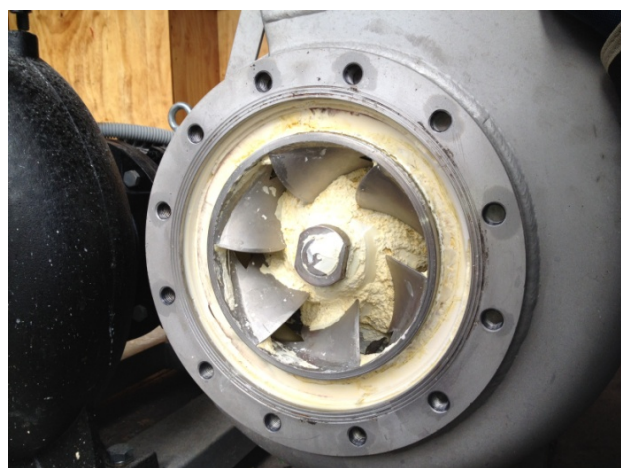
8" pump prior to relocation of reagent input.
