**60 megalitres of highly acidic water with extreme fluctuations in acidity treated with the CRAB's automated reagent correlation system.**

<b>Name</b>	<b>Gold Coast City Council Quarry</b>
<b>Site Location</b>	South East Queensland
<b>Site Problem</b>	pH & Acidity
<b>Water Volume</b>	58 Megalitres
<b>Water pH</b>	2.8 pH
<b>Acidity</b>	114mg/l to 296mg/l
<b>Suspended Solids</b>	Above license limits
<b>Treatment Objective</b>	Environmental Release
<b>What is causing the problem</b>	Quarrying and rainfall
<b>Dams/Pits</b>	1
<b>Length of water body</b>	195 metres
<b>Width of Water body</b>	68 metres
<b>Water Depth</b>	To 7.2 metres
<b>Bottom Type</b>	Rough and erratic
<b>Aquatic Flora</b>	None
<b>Vehicle Access and Flora</b>	Road access no Flora
<b>Environmental Sensitivity</b>	Contained and Controlled
<b>Aquatic Life</b>	None
<b>Drains or Streams nearby</b>	Yes – environmental risk
<b>Regulatory requirements</b>	Yes - discharge
<b>Urgency level</b>	Very urgent – stopping operations

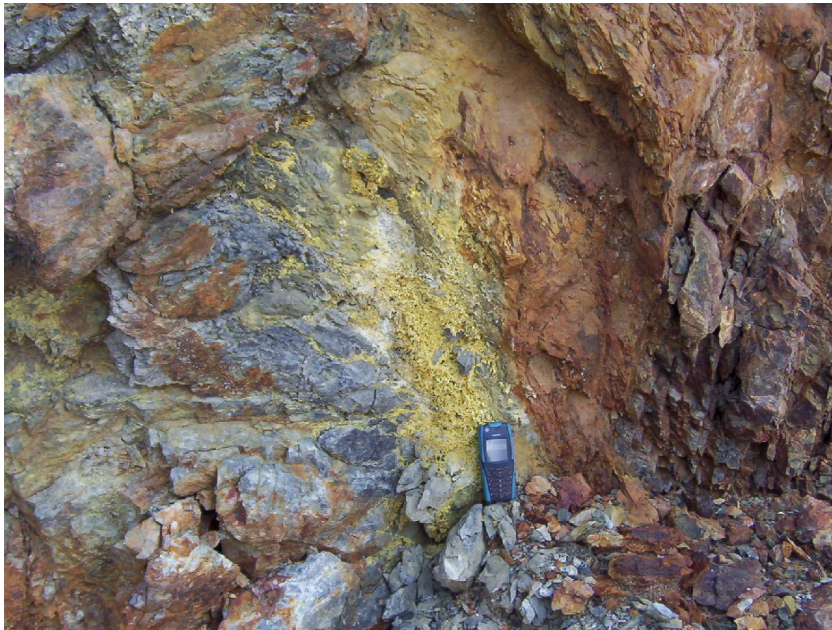
The North Eastern floor of the pit has a low flow of ground water leaching from the rock face. This area has a shale seam with extreme acidity forming. This acidity is visible in the form of a yellow crystalline material formed from the oxidation of pyritic rock and shale. This material during rain dissolves and leaches into the Containment pit carrying dissolved metals.

There are several other highly acidic acid forming areas to the south of this area in close proximity to the pit. The pyritic shale seam which is producing a large amount of acid is situated to the east of the pit and intersects the pit wall and possibly the bottom of the pit. Luckily this seam is only partially exposed in a few places. Exposure and blasting has produced extreme acidity from this shale body.

**Acid formation**

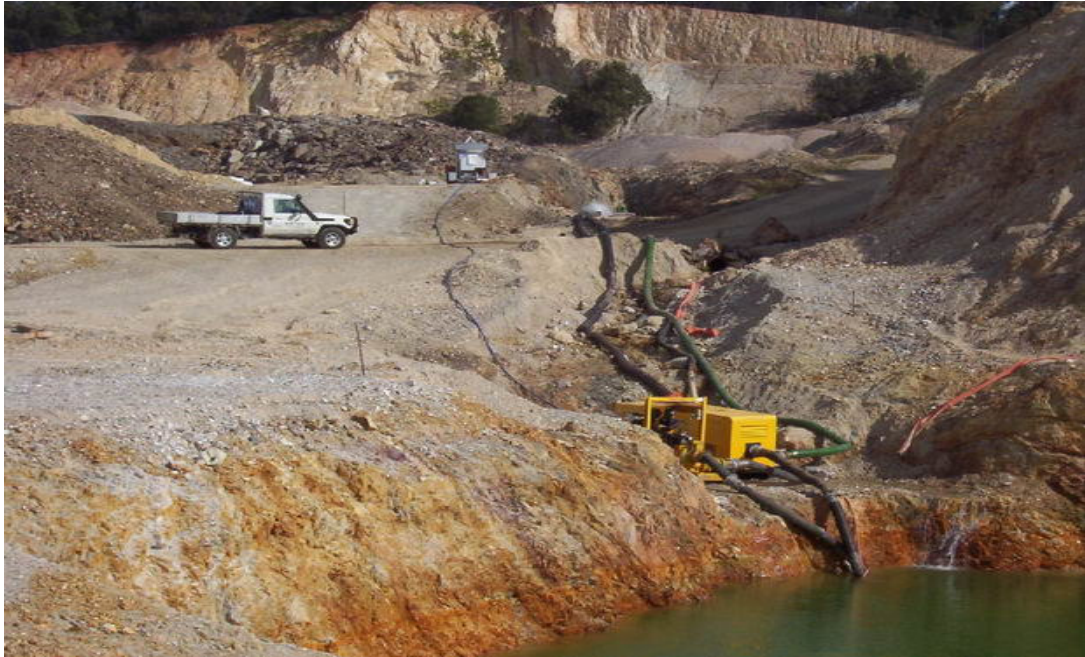
**Two 8 inch pumps and CRAB treating fluctuating acidity of pit water.**

The dewatering system used with the (IBTS) was two 8 inch pumps transferring approximately 750,000 litres per hour.

Due to the erratic re-acidification during dewatering, it was decided to treat the pit water using the CRAB ATS750 and its automated pH correlation Inline Bulk Treatment System (IBTS). This system automatically adjusts reagent output to match a preprogrammed pH setting. This system was used to produce precise treatment and dewatering results.

Acid Solutions treated the remaining 40 megalitres at a dewatering flow rate of 700 to 750 cubic metres per hour (0.7-0.75 megalitres/hr)

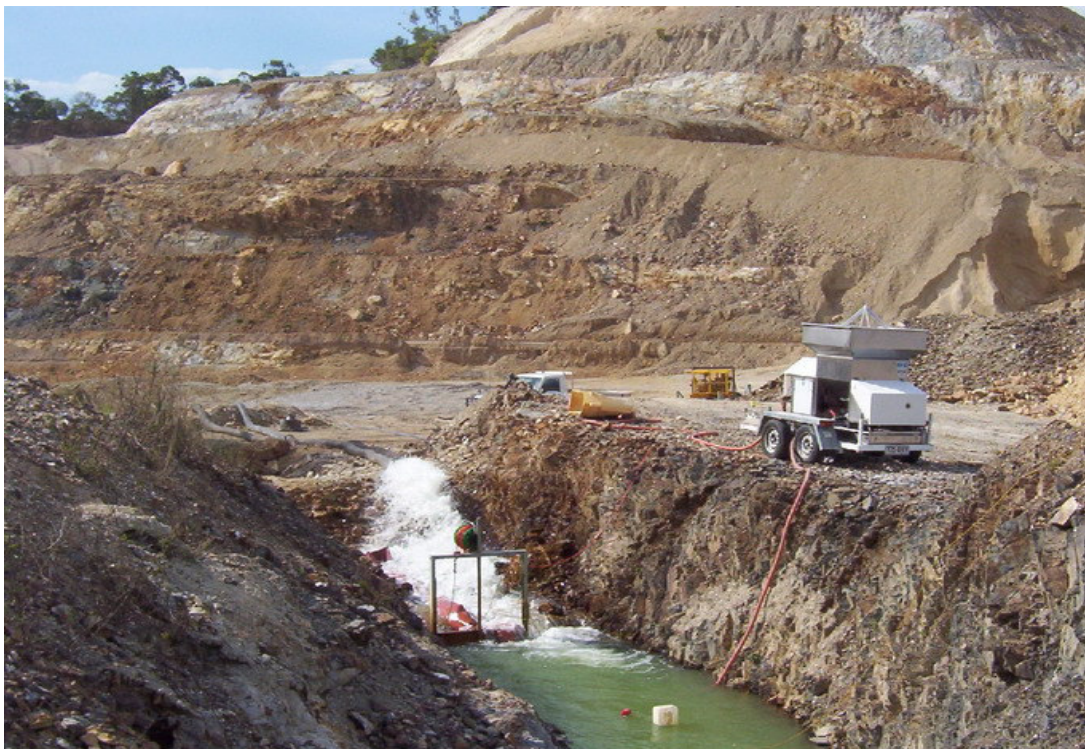
**CRAB treating 750,000 litres per hour.**

This caused large fluctuations in treatment rate as the acidity of the pit was not uniform due to channels of acid leaching from the gravel. The CRAB's automatic correlation system coped well with the extreme changes in acidity.
